EVOLUTION OF THE LOWER MSZANKA CHANNEL SECTION AFTER TRAINING USING STAGE CORRECTION METHOD

Joanna Korpak

Cracow University of Technology

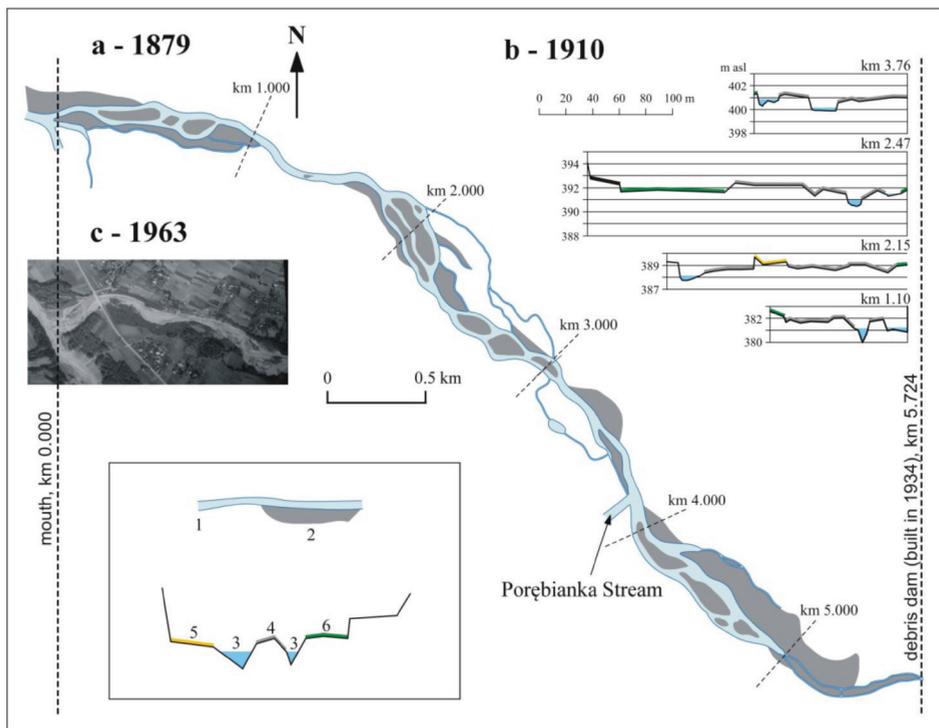
By the end of the 19th and at the beginning of the 20th century the channel in the lower Mszanka course was braided, alluvial with large central and lateral bars, some of which were utilised as pastures or arable lands (project no 11/90/8, 1910). The channel width exceeded 100 m, in some places reaching even 300 m (Fig. 2a, b). The river loading at this section considerably exceeded its transport ability, as evidenced by the deposition of carried material. Uplifting channel bottom posed a flood hazard for the adjoining agricultural lands. To stave off this problem, a decision was made to construct a debris dam which would arrest the transported material. The project was a part of the plan of systematic channel consolidation along a 12.5 km long Mszanka River reach, developed by the Commission for River Training in Galicia at Imperial-Royal Governorship in Lvov in 1910 (project 11/90/8, 1910). The project was never completed. The dam was constructed in 1934 at 5.724 km of the river in the valley necking. The channel was 20 m wide. The dam, one of the oldest in the Podkarpacie region was a stone structure with a height of 3.3 m. The fishway was situated on the right bank of the river. The dam reservoir capacity was 78,000 m³. In the subsequent years the structure was destroyed several times (by floods in 1964, 1970 and 1997) and renovated (the last time in 1999, project no. 1750, 2000). The dam broke the continuity of the fluvial system and divided the channel into two sections, which from that time were developing differently. Deposition dominated above the dam, whereas erosion below. The erosion undoubtedly occurred along about several hundred metres long section, situated immediately below the structure. Such length of the erosive section was suggested by the research on other channels below dams with similar dimensions (Korpak 2007b, Korpak *et al.* 2008). Deposition of material prevailed below this reach, as evidenced by the aerial photograph of 1963 (Fig. 2c). In this place the channel still remained braided, of a smaller width than at the turn of the 19th and 20th century, but still very wide (up to 160 m). Values of the minimum annual water stages reveal alternativeness of brief aggradation and degradation episode causing that until 1964 the channel at this cross section revealed vertical stability (Fig. 3).

Figure 2. Development of the lower section of the Mszanka channel before regulation: a – in 1879 (on the basis of the Austrian topographic map), b – channel cross sections in 1910 (according to the project no. 11/90/8, 1910), c – in 1963. 1 – water, 2 – bar, 3 – channel with water, 4 – bar, 5 – pasture, 6 – shrubs

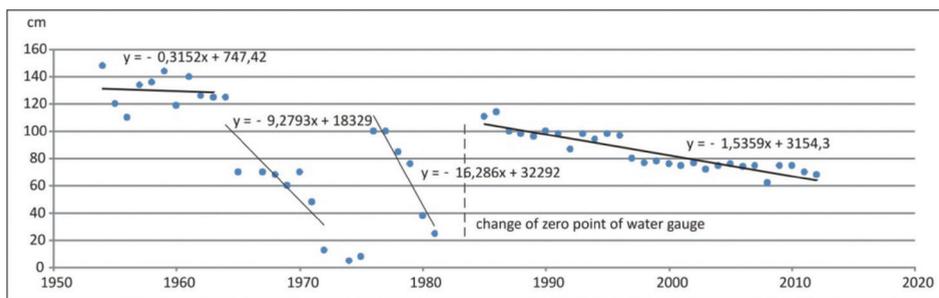
Figure 3. Lowering of the minimum annual water stages of the Mszanka River at the Mszana Dolna gauging station as an indicator of incision rates

reach below the debris dam. According to the minimum annual water stages at the Mszana Dolna gauging station, channel deepening at that time was very intensive. At various points of the longitudinal profile the bottom lowered by 1-3, usually by ca. 2 m (project 3337, 1977, Fig. 3). Information about the first period of stage correction realisation may be found in the aerial photograph of 1976 (Fig. 4a). It shows that the channel was levelled and its shape and bottom structure were destroyed. Subsequently, a new single-thread flow regulation route was constructed along the artificially delineated course line. Subsequent drop structures and steps were erected towards the river mouth. Width of the active channel decreased considerably.

Stage correction was developed in response to increased channel slope and its rapid deepening after construction of the debris dam at 5.724 km of the river. The strongest deepening occurred in the years: 1964-1972 and in 1976-1981 (Fig. 3). Training works were conducted between these periods, so the values of the minimum stages are incomparable. Each of the training stages comprised the channel narrowing, its straightening and cutting off lateral meanders, which considerably diminished the flow cross-section. The channel along river section trained with drop structures revealed a relative horizontal and vertical stability, whereas it was very unstable below. Problems appeared particularly during flood water flow. Flood water was flowing with a high velocity through the narrowed flow regulation route and strongly eroded the bottom and channel bank. Engineering structures were also damaged during floods. The training conducted to limit erosion did not eliminate the problem but moved it closer to the mouth. Therefore, sometime later a decision was made to train the next section. Finally the stage correction covered the whole length of the Mszanka lower course. However, the problem of erosion remained. The diagram of minimum water stages shows that the tendency for channel deepening lasts continuously in the channel, although the process is less intensive (Fig. 3). Strong erosion occurs in the Raba channel below its junction with the Mszanka. According to the course on minimal annual water stages over the last 100 years at water gauging station

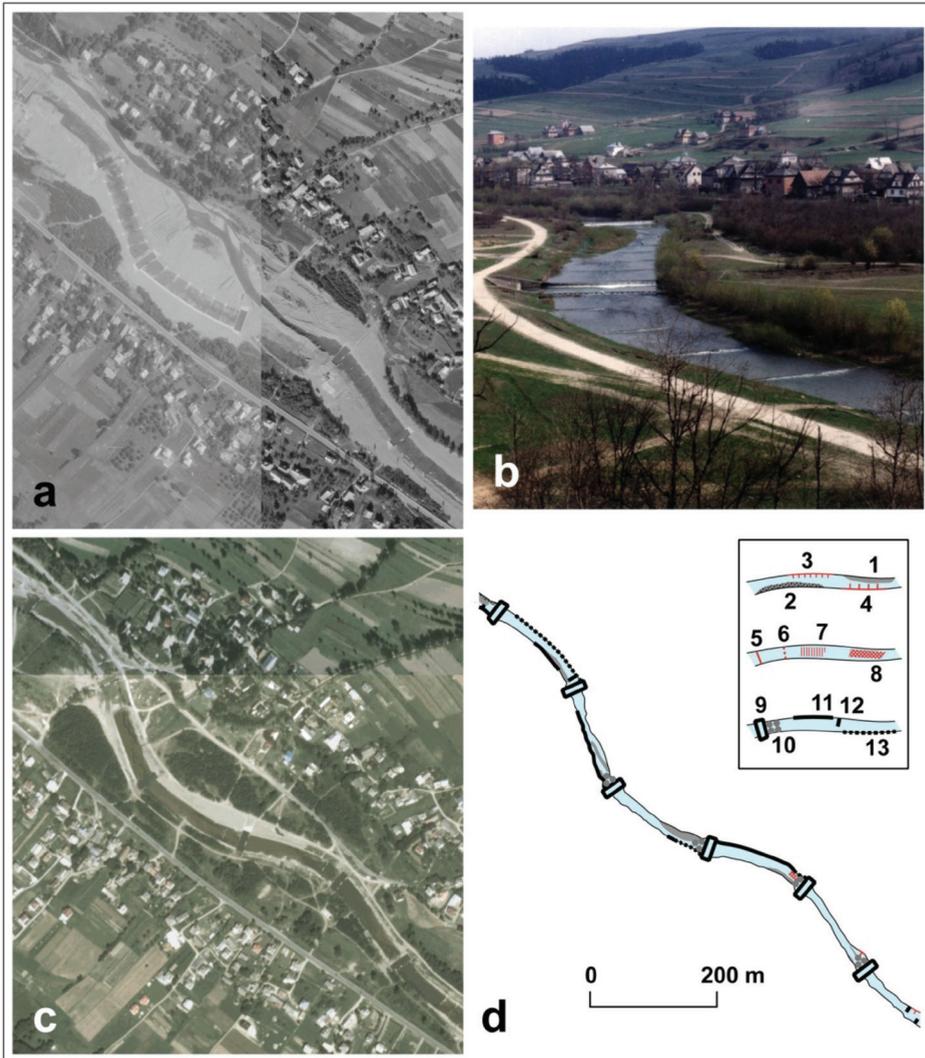
The channel section included in the 1st training stage revealed a relative horizontal and vertical stability. Fragments of the former active channel, which were “cut off” due to the training and narrowing, were transformed into a floodplain and in some place even into a terrace (Fig. 4b).

Figure 4. Change of the Mszanka channel morphology at the section regulated during the first training period : a – 1976, b – 1992 (Photo M. Komędera), c – 1997, d – 2015 (on the basis of the terrain mapping). 1 – bar, 2 – vegetated bar, 3 – cutbanks (height >2m), 4 – cutbanks (height 0-2 m), 5 – rocky step, 6 – boulder step, 7 – riffle, 8 – rocky outcrop, 9 – concrete drop structure, 10 – oversized boulders, 11 – embankment of concrete elements, 12 – concrete step, 13 – rip-rap.

Serious changes in the channel morphology were the result of a high flood in July 1997. However, renovation works were conducted immediately in the channel, as may be seen in the aerial photograph taken only a month after the flood. The section from the debris dam to the Porębianka mouth was almost wholly cleared and the banks, especially concave ones, were renovated, which evidences intensive activity of lateral erosion during the flood (Fig. 4c).

The terrain mapping repeated in 2015 revealed considerable changes in the channel morphology. Along its whole length the river was incised into the bedrock. A thin and discontinuous alluvia layer was present only in some places. Numerous rocky outcrops appeared in the bottom (Fig. 4d, 5d, 6d, 7b). A small, comparable number of bars occurred at each river section, whereas the forms differed considerably with their sizes (Table 1). At the section trained during the first two periods of training, the bars were small and usually lateral (Fig. 4d, 5d). The section regulated in 2003 revealed the presence of large bars, of which the biggest were central forms (Fig. 6d). Big cutbanks appeared at this section (Fig. 7c), as well as rocky steps with an average height of ca. 0.25 m. Few and small erosion forms visible as cutbanks were observed also at the river section closest to the dam. The least of the forms were in the central river reach, which has undergone renovation works in 2013 (City Office Mszana Dolna, 2013). Engineering structures along the whole lower Mszanka section are damaged or even destroyed. It refers particularly to the bank reinforcements, which slide and fall

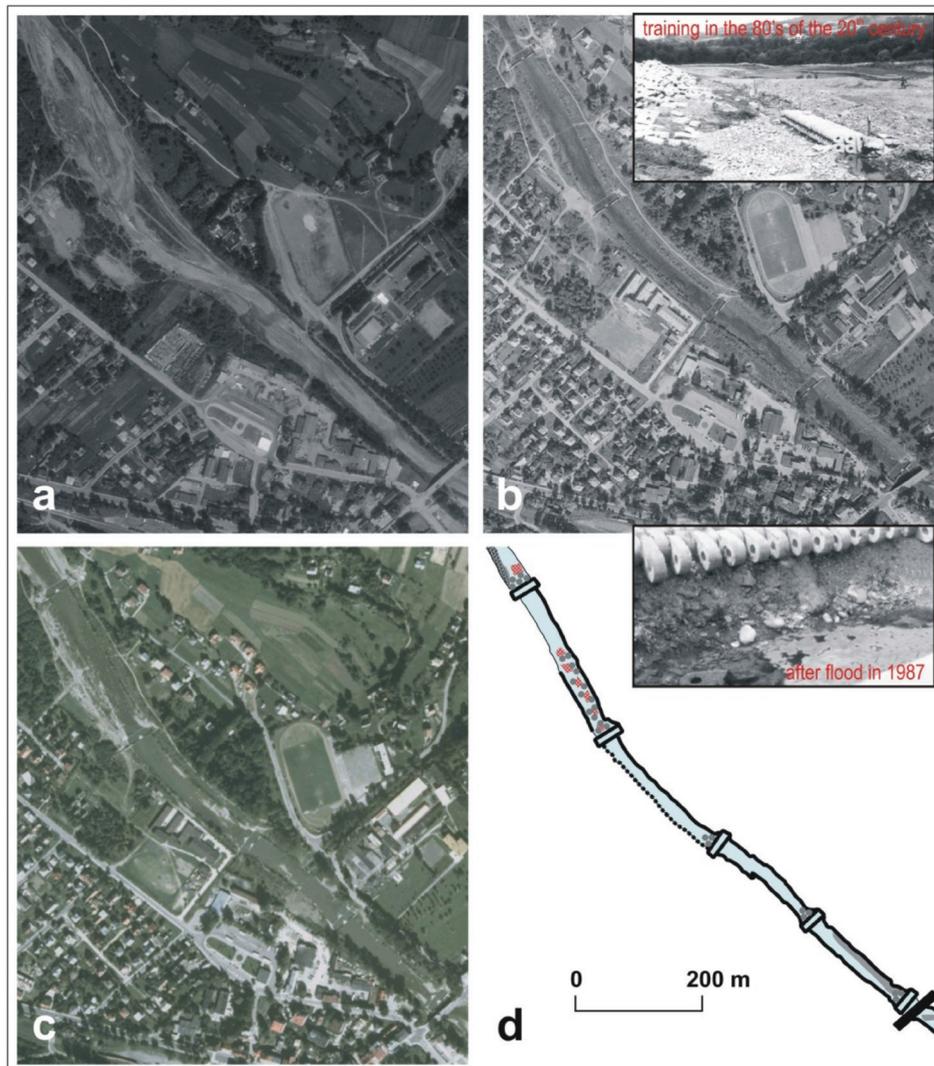
A lack of stability characterised the river section below the Porębianka mouth. Erosion occurring at this section caused the bottom deepening and banks widening. The 2nd stage of training was planned in order to inhibit erosion, limit the bedload transport and to provide flood protection for the adjoining areas, municipal facilities, bridges and roads in the city of Mszana Dolna. The training works were completed in 1989 and the last drop structure was constructed at the 2.140 km of the river. The works comprised levelling of the channel bottom, which totally disturbed the armour layer of bedload and destroyed all channel forms (Photo in Fig. 5b). The artificial flow regulation route was formed (Fig. 5b). The as-built inventory conducted after the works completion revealed considerable differences between the project and real state (project 4175, 1989). The height of the drop structures was not 1 m as planned, but ranged between 0.63 and 1.21 m. The value of channel gradient, instead of expected 5.5‰ along the whole reach, differed between the structures (2.7-4.7‰). The results of considerable reduction of the flowing water volume and negligence of the executor became apparent quite soon. Numerous damages of the new route (acc. to project no. 4175, 1989) were noted already after a small flood wave passing in May 1987 (i.e. even before the works were completed). Potholes up to 1 m deep formed before some drop structure crests. The bottom basins armouring of

gabion rock mattresses was damaged or totally destroyed and in these places 0.3-1.1m potholes formed. Concrete steps were scoured and 0.2-1.3 m deep potholes were forming below them. Some concrete steps and bank reinforcements were damaged or destroyed (Photo in Fig. 5b).

Figure 5. Change of the Mszanka channel morphology at the section regulated during the second period of training: a – 1976, b – 1993 (photographs of the as-built inventory of the flow regulation route acc. to project 4175), c – 1997, d – 2015 (based on terrain mapping). Legend as in Fig. 4.

Numerous bars, visible in the channel bed below the Porębianka mouth were mostly deposited during the flood (Fig. 5c). Many drop structures were partly or wholly covered by the bedload. Concave banks were undercut, which caused their local scouring and destruction of bank reinforcements. Renovation of the analysed channel section (3.928-2.140 km) was carried out in 1998 (acc. to Zestawienie... 2004). Both banks were armoured with concrete prefab bands and the channel was cleared by removing the accumulation forms. Subsequent renovation works were conducted after the flood in 2001.

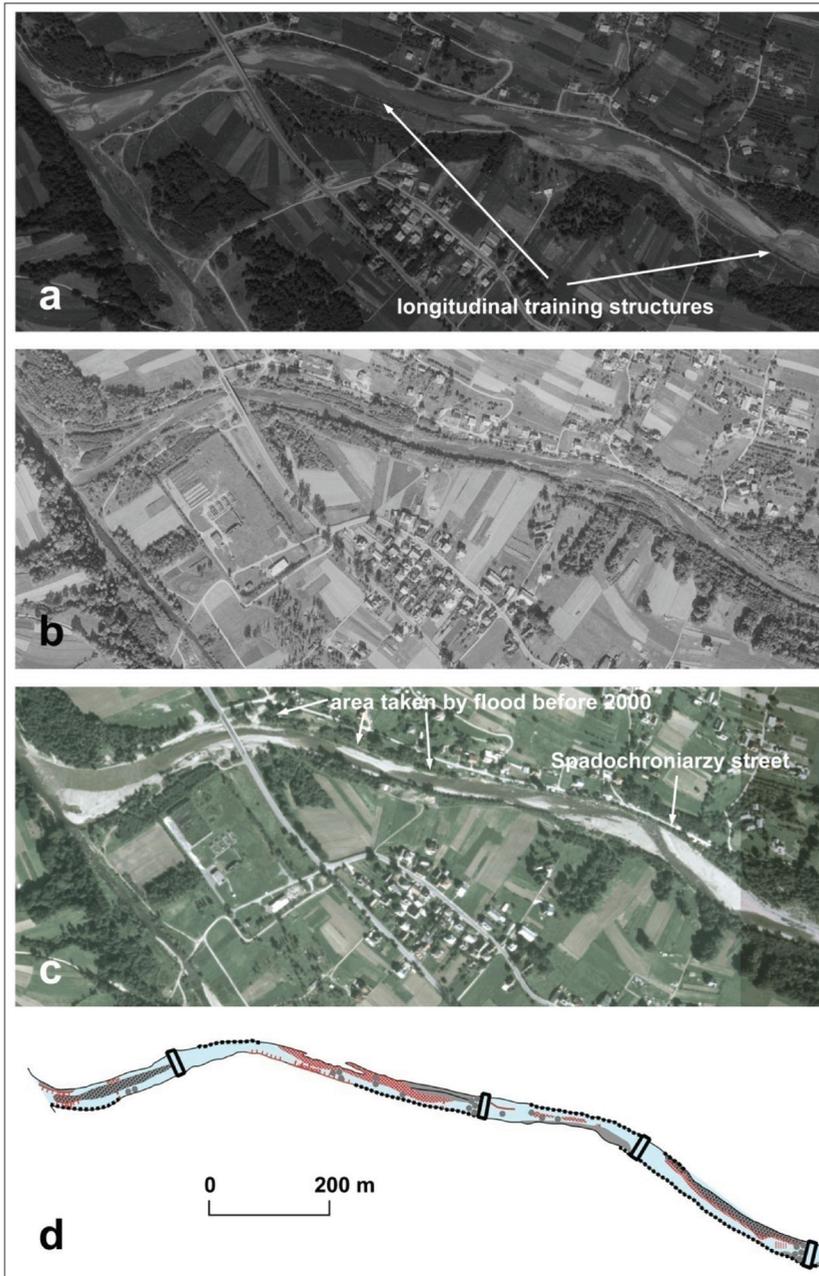
At that time the riverbed below the Porębianka River mouth was alluvial and locally divided into several arms, while its maximum width reached ca. 100 m (Fig. 5a, 6a). The river showed tendency for a lateral migration and going wild (Fig. 5a, 6a). Longitudinal training was conducted at several river sections to protect its banks against erosion (project no. 3337, 1977). The training is visible in aerial photographs (Fig. 6a).

In its final, mouth section, so far not included in training by means of stage correction, in 1993 the channel was single thread and narrow. Its width did not exceed 25 m (Fig. 6b). It was the result of training conducted in the 1970s using groynes and longitudinal dikes.

Figure 6. Change in the Mszanka channel morphology at the section regulated during the third period of training: a – 1976, b – 1993, c – 1997, d – 2015 (based on the terrain mapping). Legend as in Fig. 4.

The final, mouth section of the Mszanka River was considerably widened in August 1997 in comparison with its state in 1993 (Fig. 6c). The floodwater, overflowing the artificially narrowed channel, destroyed bank reinforcements.

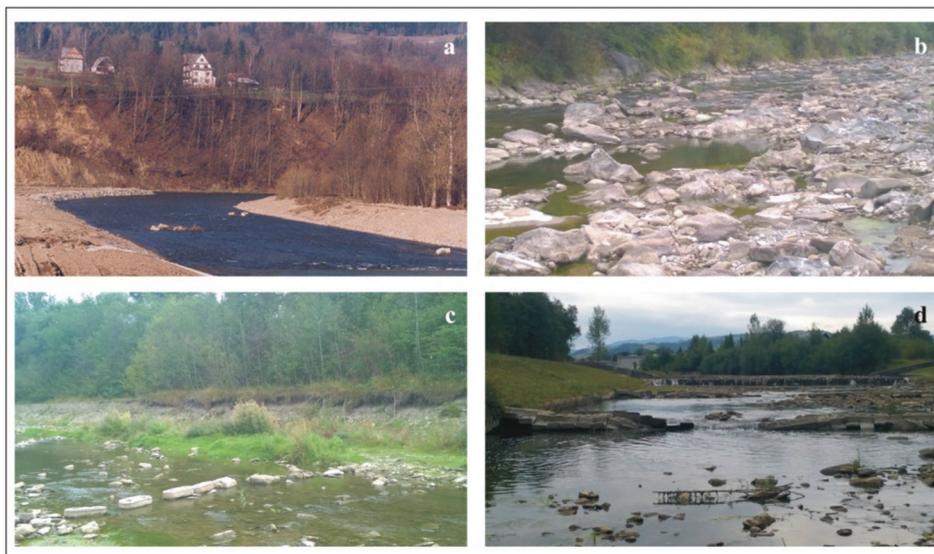
Figure 7. Development of the Mszanka channel in 2004 and 2015: a – the channel in 2004 without any fluvial forms after freshly conducted training, b-d erosional channel in 2015: b – rocky outcrops between drop structures, c – cutbanks within the flow regulation route, d – destroyed concrete steps between drop structures

The channel width after the flood was already 35-70 m. The subsequent floods between 1997 and 2000 caused further damage to bank reinforcements, the majority of which were suitable for demolition. Tendencies for the river lateral migration were apparent, due to which between 1997 and 2000 the channel widened considerably, in some places even 3 times. It reached its maximum width of ca. 100 m before the bridge (project 4175, 1989, Fig. 6c). During one of the floods the river took away ca. 35 m wide wooded bank strip which separated it from the Spadochroniarzy street (Fig. 6c). From that time the channel adjoined the road, which threatened its destruction during the next flood. Therefore, in 2000 the third part of training works using stage correction was planned at the section of 2.140 – Mszanka inflow into the Raba River. The construction was completed in 2003. The channel was narrowed to 34 m and at the same the active channel area was diminished ca. twice. Six concrete drop structures were constructed. The building works levelled the channel bottom and destroyed all accumulation forms (Fig. 7a).

into the river. Almost all concrete steps constructed between the drop structures were removed (Fig. 7d).
