## **EVOLUTION OF THE LOWER MSZANKA CHANNEL SECTION AFTER TRAINING USING STAGE CORRECTION METHOD**

***Joanna Korpak***

*Cracow University of Technology*

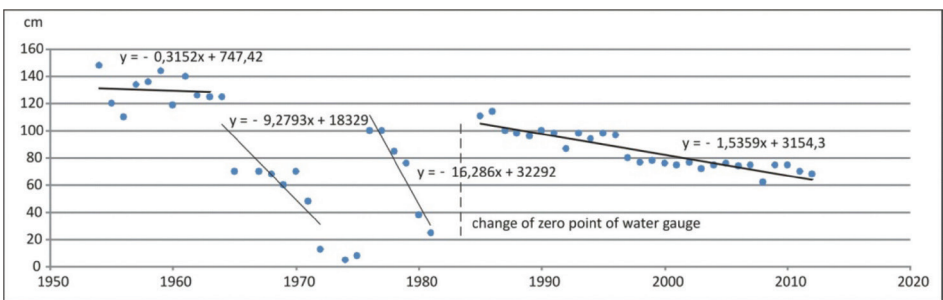
**Figure 3.** Lowering of the minimum annual water stages of the Mszanka River at the Mszana Dolna gauging station as an indicator of incision rates

reach below the debris dam. According to the minimum annual water stages at the Mszana Dolna gauging station, channel deepening at that time was very intensive. At various points of the longitudinal profile the bottom lowered by 1-3, usually by ca. 2 m (project 3337, 1977, Fig. 3). Information about the first period of stage correction realisation may be found in the aerial photograph of 1976 (Fig. 4a). It shows that the channel was levelled and its shape and bottom structure were destroyed. Subsequently, a new single-thread flow regulation route was constructed along the artificially delineated course line. Subsequent drop structures and steps were erected towards the river mouth. Width of the active channel decreased considerably.

Stage correction was developed in response to increased channel slope and its rapid deepening after construction of the debris dam at 5.724 km of the river. The strongest deepening occurred in the years: 1964-1972 and in 1976-1981 (Fig. 3). Training works were conducted between these periods, so the values of the minimum stages are incomparable. Each of the training stages comprised the channel narrowing, its straightening and cutting off lateral meanders, which considerably diminished the flow cross-section. The channel along river section trained with drop structures revealed a relative horizontal and vertical stability, whereas it was very unstable below. Problems appeared particularly during flood water flow. Flood water was flowing with a high velocity through the narrowed flow regulation route and strongly eroded the bottom and channel bank. Engineering structures were also damaged during floods. The training conducted to limit erosion did not eliminate the problem but moved it closer to the mouth. Therefore, sometime later a decision was made to train the next section. Finally the stage correction covered the whole length of the Mszanka lower course. However, the problem of erosion remained. The diagram of minimum water stages shows that the tendency for channel deepening lasts continuously in the channel, although the process is less intensive (Fig. 3). Strong erosion occurs in the Raba channel below its junction with the Mszanka. According to the course on minimal annual water stages over the last 100 years at water gauging station

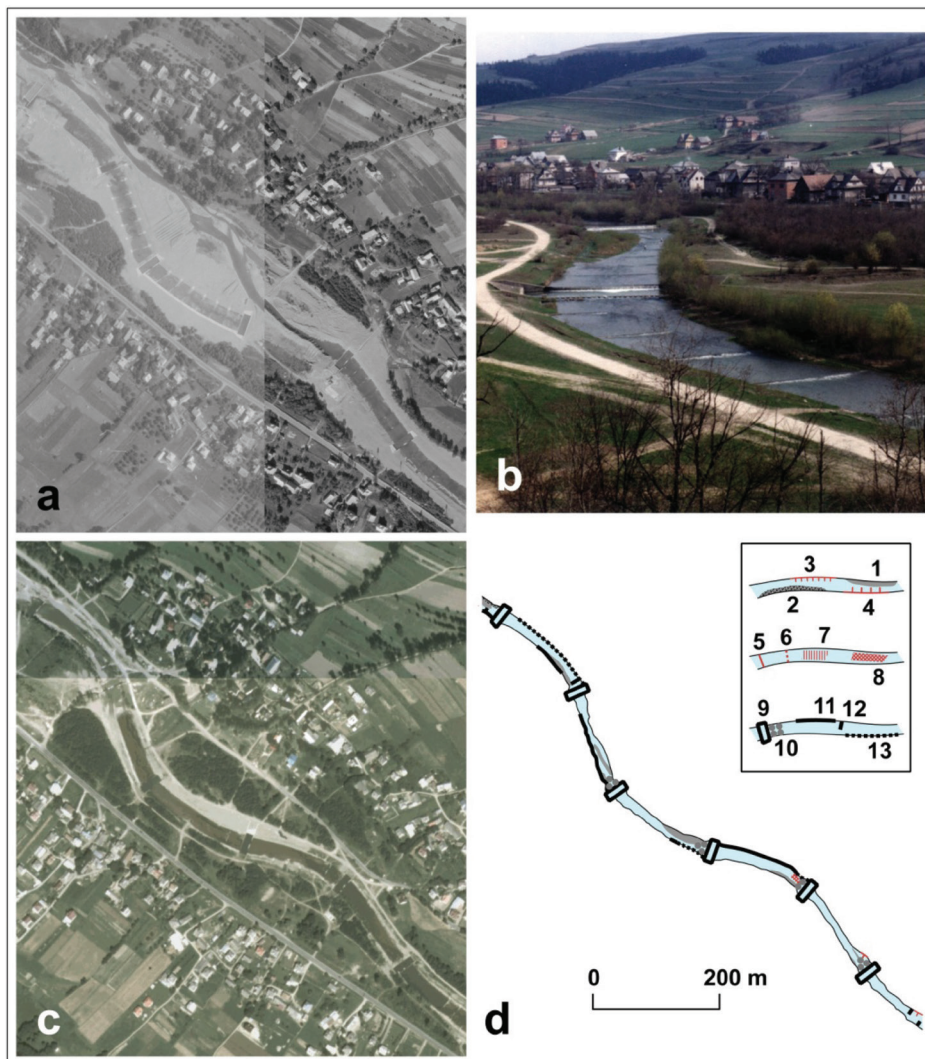
The channel section included in the 1<sup>st</sup> training stage revealed a relative horizontal and vertical stability. Fragments of the former active channel, which were “cut off” due to the training and narrowing, were transformed into a flood-plain and in some place even into a terrace (Fig. 4b).

**Figure 4.** Change of the Mszanka channel morphology at the section regulated during the first training period : a – 1976, b – 1992 (Photo M. Komędera), c – 1997, d – 2015 (on the basis of the terrain mapping). 1 – bar, 2 – vegetated bar, 3 – cutbanks (height >2m), 4 – cutbanks (height 0-2 m), 5 – rocky step, 6 – boulder step, 7 – riffle, 8 – rocky outcrop, 9 – concrete drop structure, 10 – oversized boulders, 11 – embankment of concrete elements, 12 – concrete step, 13 – rip-rap.

Serious changes in the channel morphology were the result of a high flood in July 1997. However, renovation works were conducted immediately in the channel, as may be seen in the aerial photograph taken only a month after the flood. The section from the debris dam to the Porębianka mouth was almost wholly cleared and the banks, especially concave ones, were renovated, which evidences intensive activity of lateral erosion during the flood (Fig. 4c).

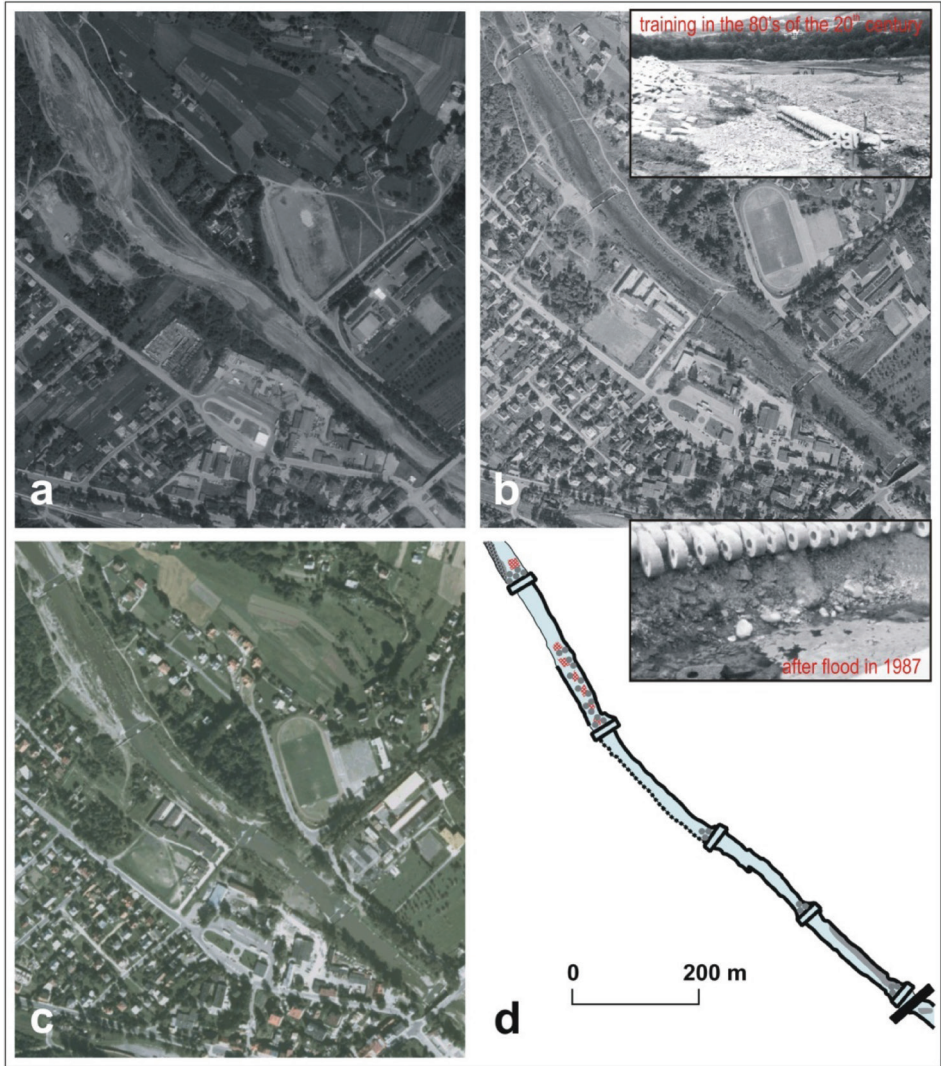
gabion rock mattresses was damaged or totally destroyed and in these places 0.3-1.1m potholes formed. Concrete steps were scoured and 0.2-1.3 m deep potholes were forming below them. Some concrete steps and bank reinforcements were damaged or destroyed (Photo in Fig. 5b).

**Figure 5.** Change of the Mszanka channel morphology at the section regulated during the second period of training: a – 1976, b – 1993 (photographs of the as-built inventory of the flow regulation route acc. to project 4175), c – 1997, d – 2015 (based on terrain mapping). Legend as in Fig. 4.

Numerous bars, visible in the channel bed below the Porębianka mouth were mostly deposited during the flood (Fig. 5c). Many drop structures were partly or wholly covered by the bedload. Concave banks were undercut, which caused their local scouring and destruction of bank reinforcements. Renovation of the analysed channel section (3.928-2.140 km) was carried out in 1998 (acc. to Zestawienie... 2004). Both banks were armoured with concrete prefab bands and the channel was cleared by removing the accumulation forms. Subsequent renovation works were conducted after the flood in 2001.

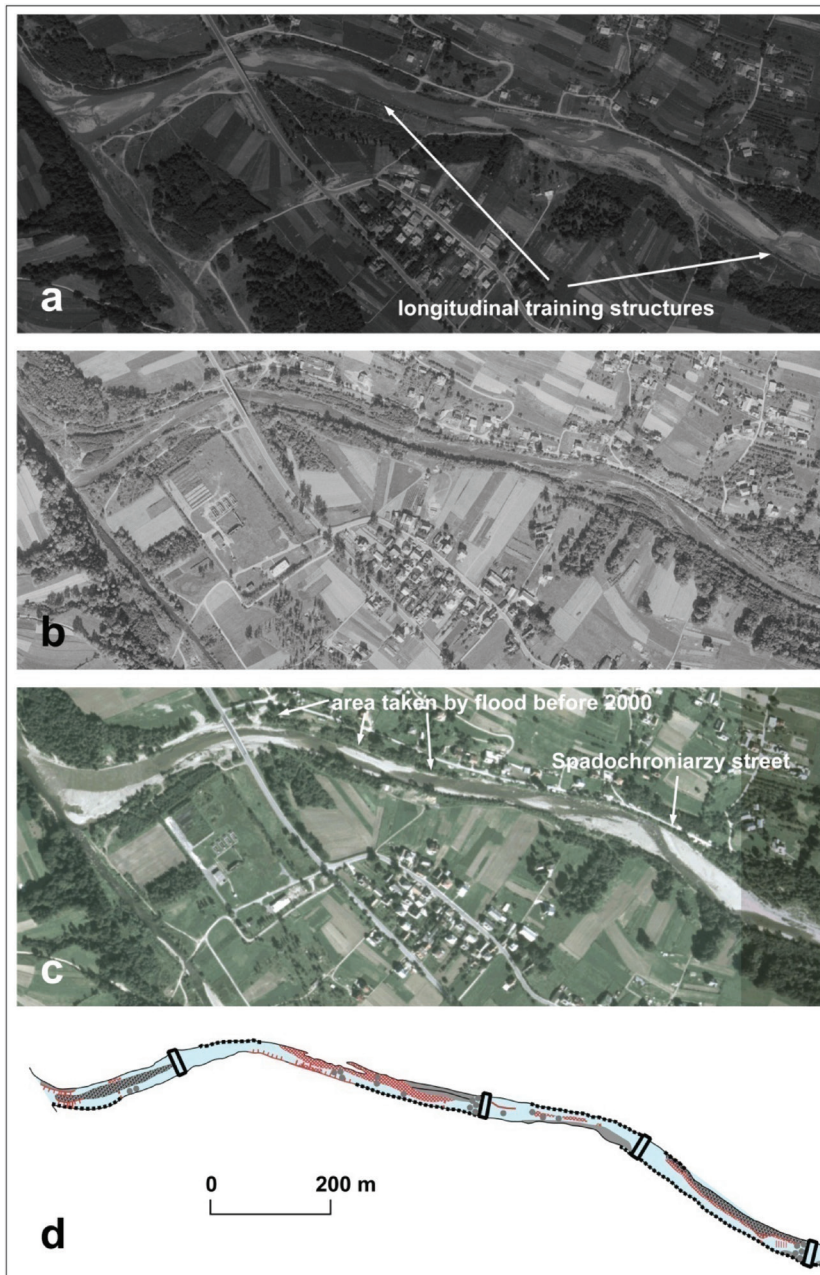
In its final, mouth section, so far not included in training by means of stage correction, in 1993 the channel was single thread and narrow. Its width did not exceed 25 m (Fig. 6b). It was the result of training conducted in the 1970s using groynes and longitudinal dikes.

**Figure 6.** Change in the Mszanka channel morphology at the section regulated during the third period of training: a – 1976, b – 1993, c – 1997, d – 2015 (based on the terrain mapping). Legend as in Fig. 4.

The final, mouth section of the Mszanka River was considerably widened in August 1997 in comparison with its state in 1993 (Fig. 6c). The floodwater, overflowing the artificially narrowed channel, destroyed bank reinforcements.

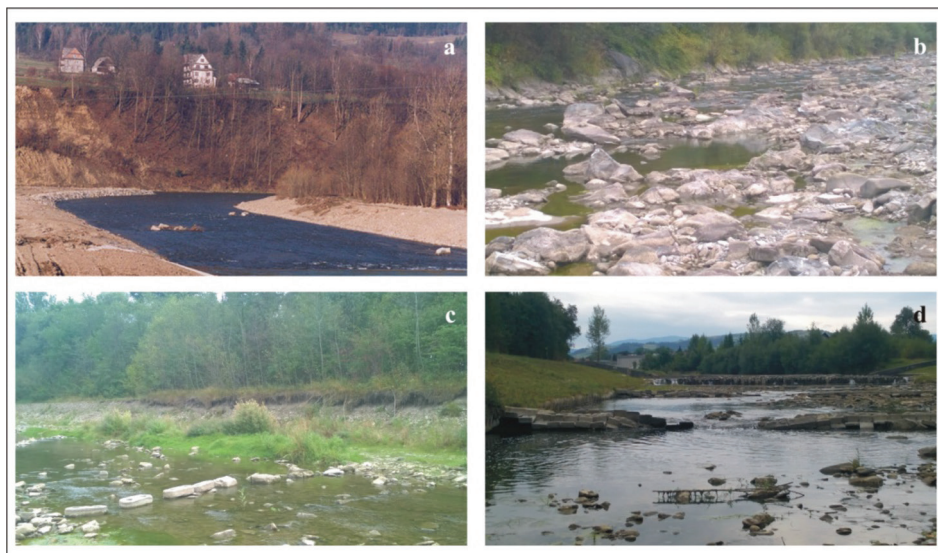
**Figure 7.** Development of the Mszanka channel in 2004 and 2015: a – the channel in 2004 without any fluvial forms after freshly conducted training, b-d erosional channel in 2015: b – rocky outcrops between drop structures, c – cutbanks within the flow regulation route, d – destroyed concrete steps between drop structures

The terrain mapping repeated in 2015 revealed considerable changes in the channel morphology. Along its whole length the river was incised into the bedrock. A thin and discontinuous alluvia layer was present only in some places. Numerous rocky outcrops appeared in the bottom (Fig. 4d, 5d, 6d, 7b). A small, comparable number of bars occurred at each river section, whereas the forms differed considerably with their sizes (Table 1). At the section trained during the first two periods of training, the bars were small and usually lateral (Fig. 4d, 5d). The section regulated in 2003 revealed the presence of large bars, of which the biggest were central forms (Fig. 6d). Big cutbanks appeared at this section (Fig. 7c), as well as rocky steps with an average height of ca. 0.25 m. Few and small erosion forms visible as cutbanks were observed also at the river section closest to the dam. The least of the forms were in the central river reach, which has undergone renovation works in 2013 (City Office Mszana Dolna, 2013). Engineering structures along the whole lower Mszanka section are damaged or even destroyed. It refers particularly to the bank reinforcements, which slide and fall

into the river. Almost all concrete steps constructed between the drop structures were removed (Fig. 7d).
