***INFRASTRUKTURA I EKOLOGIA TERENÓW WIEJSKICH
INFRASTRUCTURE AND ECOLOGY OF RURAL AREAS***

Nr 11/2010, POLSKA AKADEMIA NAUK, Oddział w Krakowie, s. 83–93

Agnieszka Sadłowska, Waclaw Bieda

**ANALYSIS OF THERMAL ENVIRONMENT INDICES
AND AIR QUALITY INSIDE
A WOODEN HISTORIC CHURCH IN WIŚNIOWA**

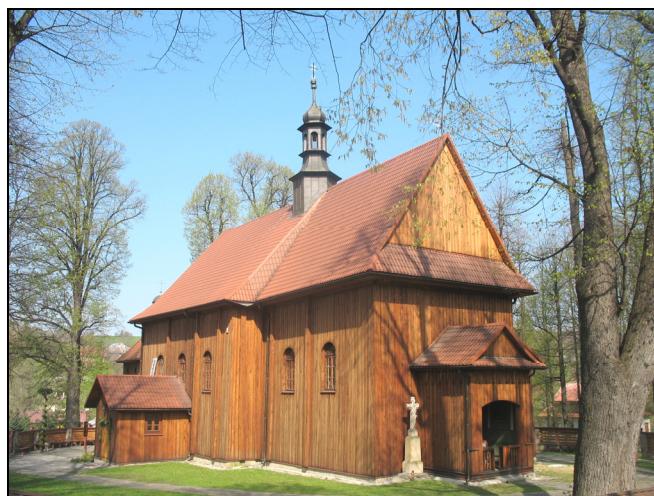
Figure 1. The church of Saint Martin in Wiśniowa as viewed from the southeast.
Photo: K. Wąs.

The wooden church of Saint Martin in Wiśniowa was built around 1730. It is a log church covered with larch clapboards (Fig. 1). During Sunday Masses, people gather in the spacious nave – 300 m² of usable floor area, yet with a large number of service attendees, the occupied zone also includes roofed vestibules adjoining the nave, particularly the wide (32m²) western vestibule. Each Sunday, 4 Masses are held at the following times: 6:30 am, 9:00 am, 11:00 am, and 5:00 pm (in winter) or 6:00 pm (in summer). Most people, approx. 400 local inhabitants, participate in the noon service (from 11:00 to 12:00), which gives about 0.83 m² per person and 7.5 m³ per person.

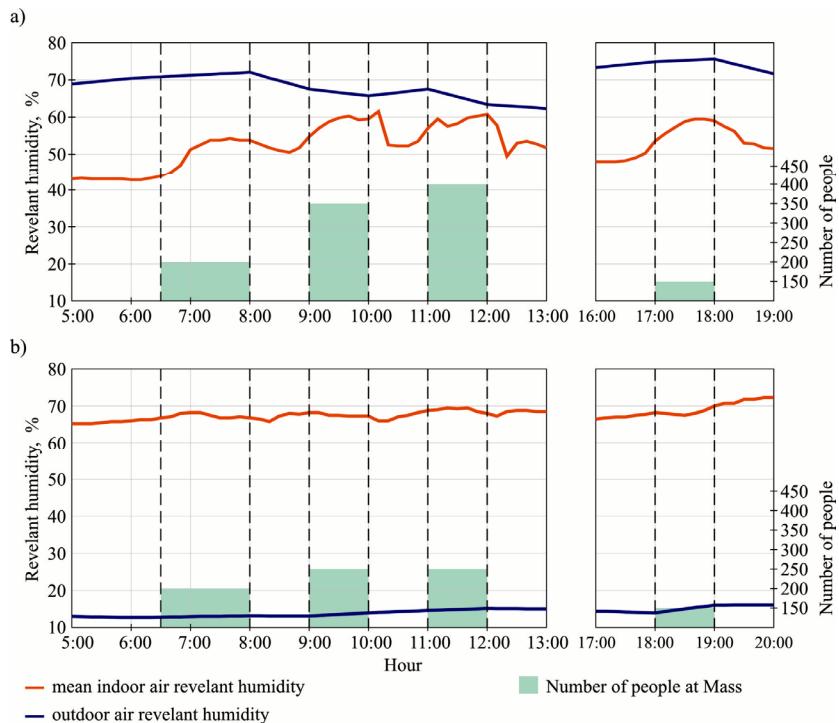
Figure 3. Relative air humidity distribution in the occupied zone and outside:
a) 6th January 2008, b) 13th July 2008

Figure 3 illustrates an exemplary distribution of relative humidity fluctuations during church services and between them in the winter (6th January 2008) and the summer (13th July 2008) seasons. It reveals that even in the case of very low outside air relative humidity (13th July 2008), inside air humidity remained at a high level, which confirms high autonomy of the building with respect to humidity.

Air relative humidity during a Mass is mostly affected by people. More significant fluctuations caused by their presence occur in the winter season. The largest disparity between the maximum and minimum relative air humidity inside the church, which amounted to 23.9%, was noted in March, whilst the narrowest span of only 4.7% was registered in May.

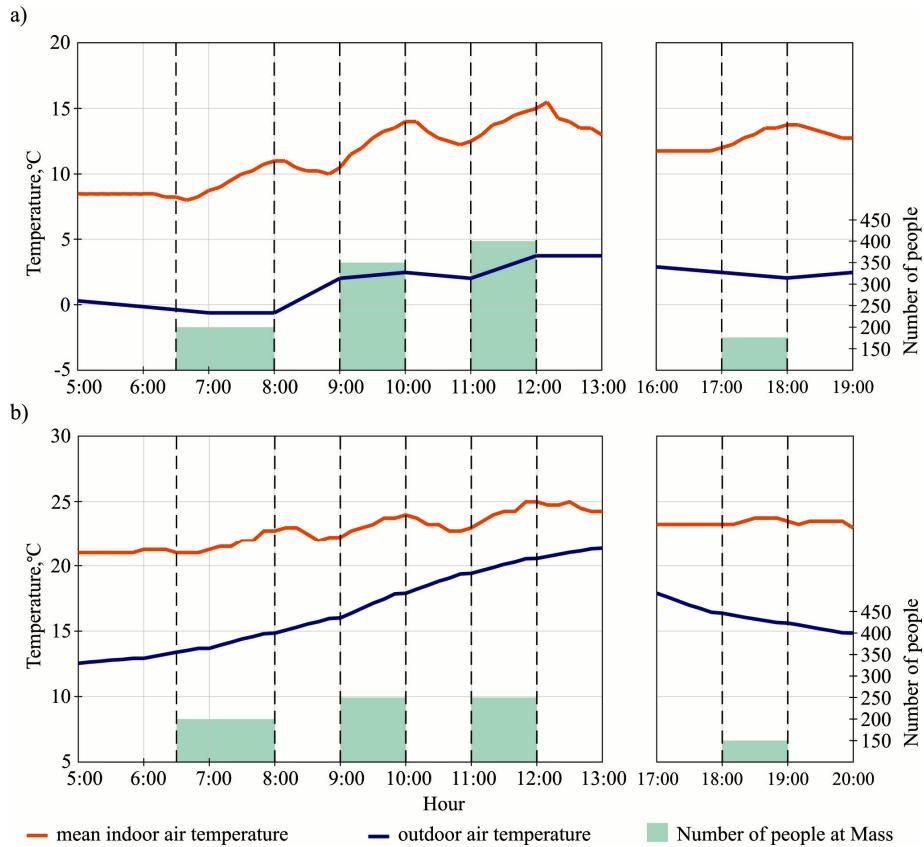
Figure 4. Temperature distribution in the occupied zone and the number of service attendees a) 6th January 2008, b) 13th July 2008

The analysis of results reveals that in the periods directly preceding and following Masses air temperature inside the church evidently decreased. This is related to a repeated procedure of opening entrance doors to the vestibules and nave whilst entering and leaving the building. In the course of the service, the temperature increased, frequently despite the decrease in outside temperature (fig. 4). The more people attended the church service, the more significantly the temperature increased.

The highest average air temperature in the occupied zone of 26.5°C was recorded on 13th July 2008 at 12:30 pm, whilst the lowest, of 5.5°C, was registered on 17th February between 5:00 to 7:00 am. Minimal values were always noted at the beginning of the 6:00 am service, which can be explained by substantial cooling of the church interior. Throughout the investigated period, maximum daily outside air temperatures were registered around noon, just after the end of the 11:00 am Mass.

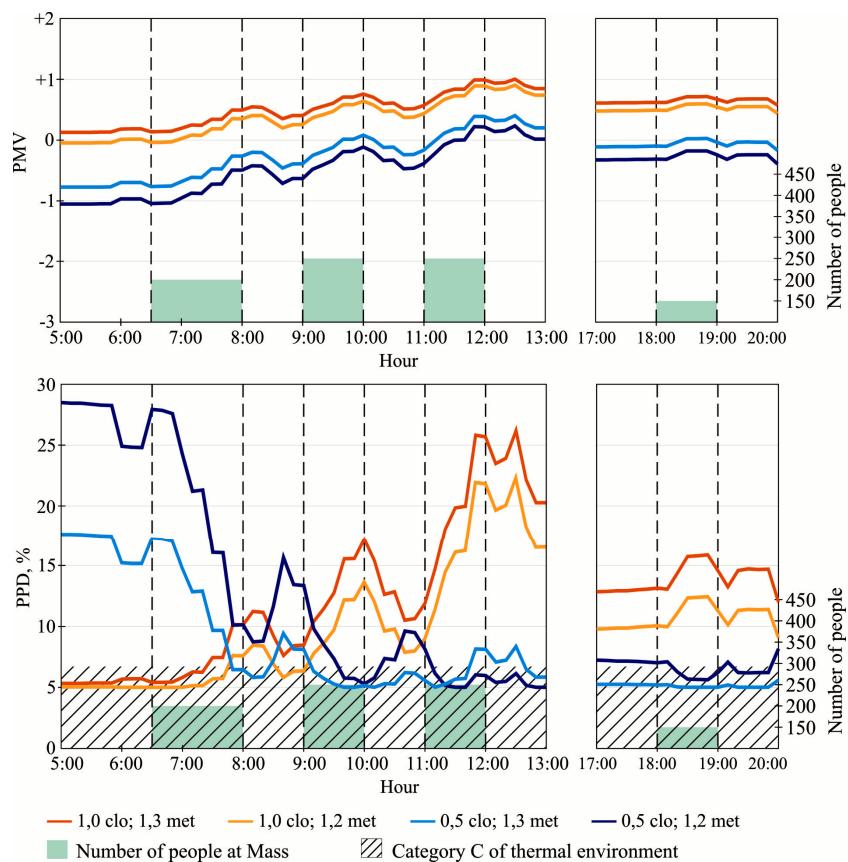
Figure 5. Predicted Mean Value and Predicted Percentage Dissatisfied for a Mass held on Sunday 13th July 2008

Based on obtained calculation results for the summer period, it can be concluded that temperature and humidity conditions inside the church of Wiśniowa were satisfactory. Assuming that insulation properties of human clothing dif-

ferred depending on weather conditions, it can be maintained that the predicted mean value PMV would stay between $-0.7 \div +0.7$. Only during the morning service, people could evaluate inside temperature as “slightly low”. At that time, the percentage of dissatisfied, apart from an insignificant number of cases, did not exceed 15% ($PPD \leq 15\%$). This means that in the summer period, the church can be classified as C category, which is a satisfactory result for a building not designed for permanent human residence.

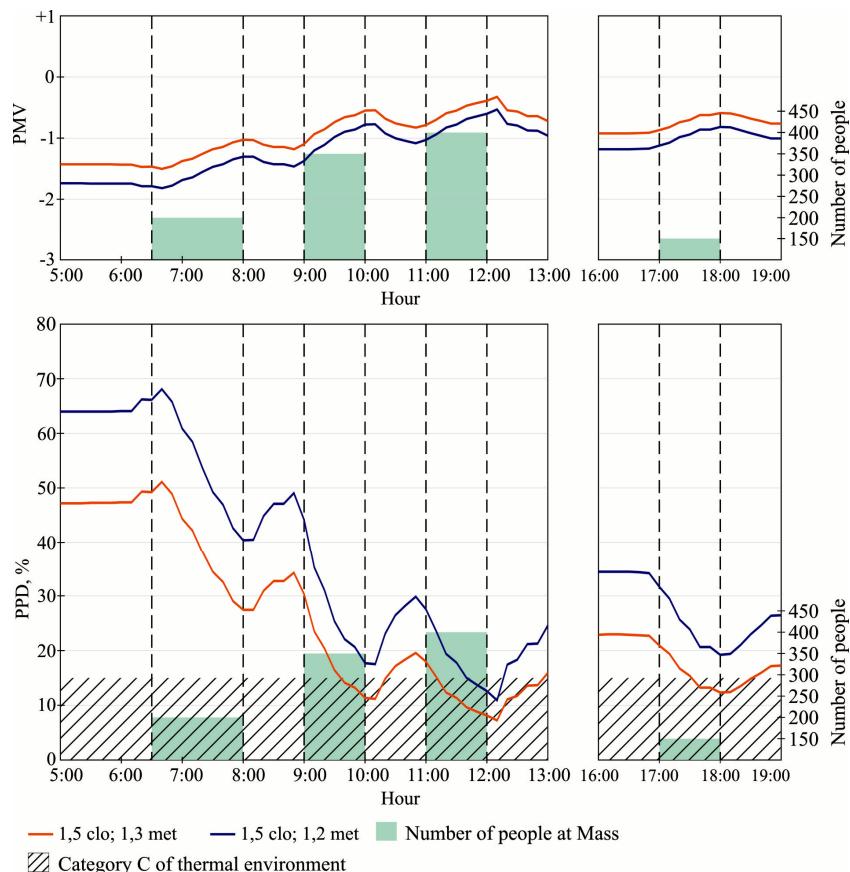
Figure 6. Predicted Mean Value and Predicted Percentage Dissatisfied for a Mass held on Sunday 6th January 2008

In the transitory and winter period, even with the assumption of highest physical activity (1.3 met), thermal comfort assessment varied between “cool” and “slightly cool”. The conducted analysis reveals that in marginal cases, particularly during morning services, PMV value could reach as low as -1.81 (thermal insulation of clothing 1.5 clo, activity 1.2 met). This means that thermal comfort assessments approximated to the “cool” level and the predicted percentage dissatisfied grew to over 86% (Fig. 6). Notably, outside temperatures did not fall below -3°C throughout the period under analysis. With colder winters, PMV values may turn out even less favourable. Therefore for the winter and transitory periods, the greatest number of temperature assessments lay beyond the categories of inside thermal comfort as defined by the PN EN ISO 7730 standard (in most cases, PPD exceeded 15%).
