DETERMINATION OF THE INFLUENCE OF BUILDING MASS ON LANDSLIDE FORMATION USING UNMANNED AERIAL SYSTEMS

Józef Sanecki, Andrzej Klewski, Marek Zygmunt, Grzegorz Stępień
Maritime University in Szczecin

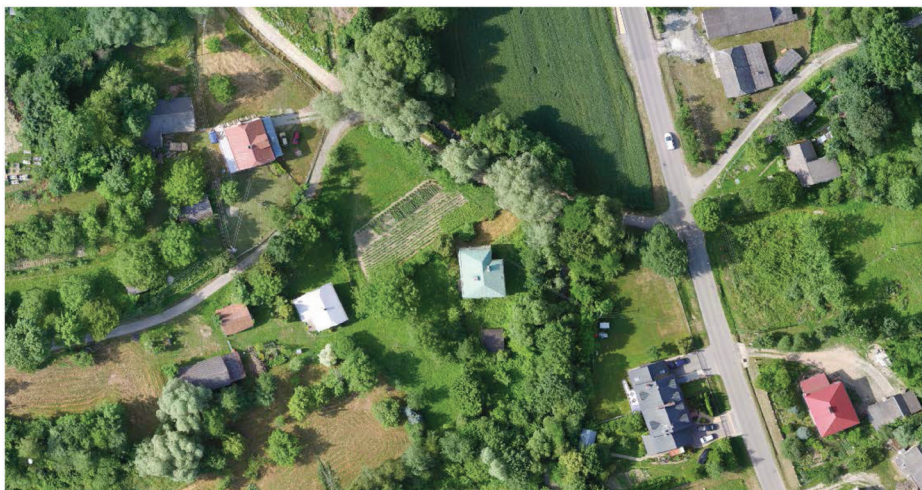
Figure 4. Digital orthophotomap of the landslide: pixel size (ground sampling distance) = 0.027 m

After creating dense point clouds, a tiled model was formulated in order to generate the final elaborations. The first step was to create the DSM with an eyelet mesh of 0.10 m, followed by the orthophotomap. The DSM was ex-

ported to the XYZ format, while the digital orthophotomap was exported to the GeoTiff format.

The final stage of the work involved regenerating the report. During the processing stage, average error points were identified for location X, Y on the orthophotomap at the 100 pixels level. In effect, the location of the points of absolute accuracy were at the level of about 1.1 m. Regarding height (DSM), the Z coordinate was obtained as follows: 165 pixels and 1.5 m absolute accuracy. Relative accuracy was obtained within limits of 3 pixels (0.08 m) for the X, Y coordinates and 5 pixels (0.11 m) for the Z coordinate (height – DSM).

6. A digital orthophotomap at a ground resolution of 0.027 m, created as a result of orthophotos taken by a UAS, allows for more detailed observation of location objects in a landslide area and the space relations occurring between them.

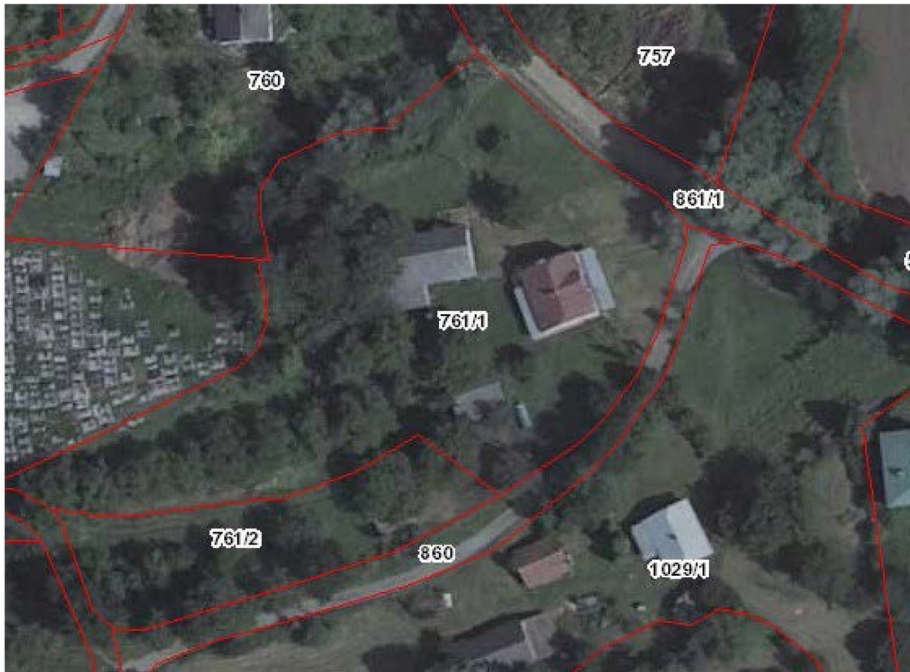
Figure 5. Localisation of building

Based on the DSM for the low landslide part, the construction calculations for the executive project for the cardiology clinic in Bielski Podlaski (Zabagło, 2014) and the cadastral map of area, the estimated medium building mass on field no. 761/1 was 85 tons. Localisation of building is on Figure 5.

According to the calculated value of the mass, there is a pressure force caused by building on the landslide. This value is 834 kN. The calculated val-
