INFRASTRUKTURA I EKOLOGIA TERENÓW WIEJSKICH
INFRASTRUCTURE AND ECOLOGY OF RURAL AREAS

EVOLUTION OF THE LOWER MSZANKA CHANNEL SECTION AFTER TRAINING USING STAGE CORRECTION METHOD

Joanna Korpak
Cracow University of Technology

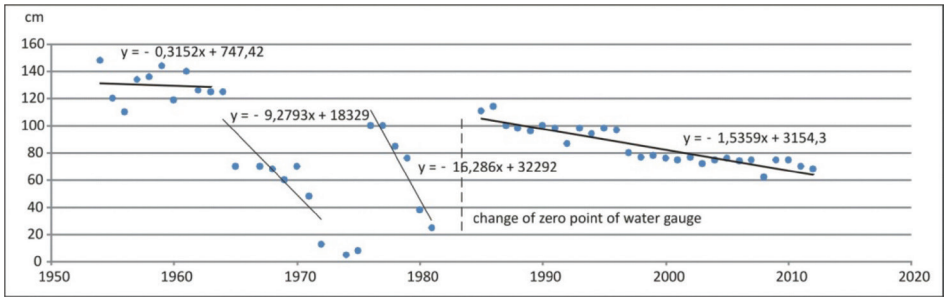
Figure 3. Lowering of the minimum annual water stages of the Mszanka River at the Mszana Dolna gauging station as an indicator of incision rates

Stage correction was developed in response to increased channel slope and its rapid deepening after construction of the debris dam at 5.724 km of the river. The strongest deepening occurred in the years: 1964-1972 and in 1976-1981 (Fig. 3). Training works were conducted between these periods, so the values of the minimum stages are incomparable. Each of the training stages comprised the channel narrowing, its straightening and cutting off lateral meanders, which considerably diminished the flow cross-section. The channel along river section trained with drop structures revealed a relative horizontal and vertical stability, whereas it was very unstable below. Problems appeared particularly during flood water flow. Flood water was flowing with a high velocity through the narrowed flow regulation route and strongly eroded the bottom and channel bank. Engineering structures were also damaged during floods. The training conducted to limit erosion did not eliminate the problem but moved it closer to the mouth. Therefore, sometime later a decision was made to train the next section. Finally the stage correction covered the whole length of the Mszanka lower course. However, the problem of erosion remained. The diagram of minimum water stages shows that the tendency for channel deepening lasts continuously in the channel, although the process is less intensive (Fig. 3). Strong erosion occurs in the Raba channel below its junction with the Mszanka. According to the course on minimal annual water stages over the last 100 years at water gauging station

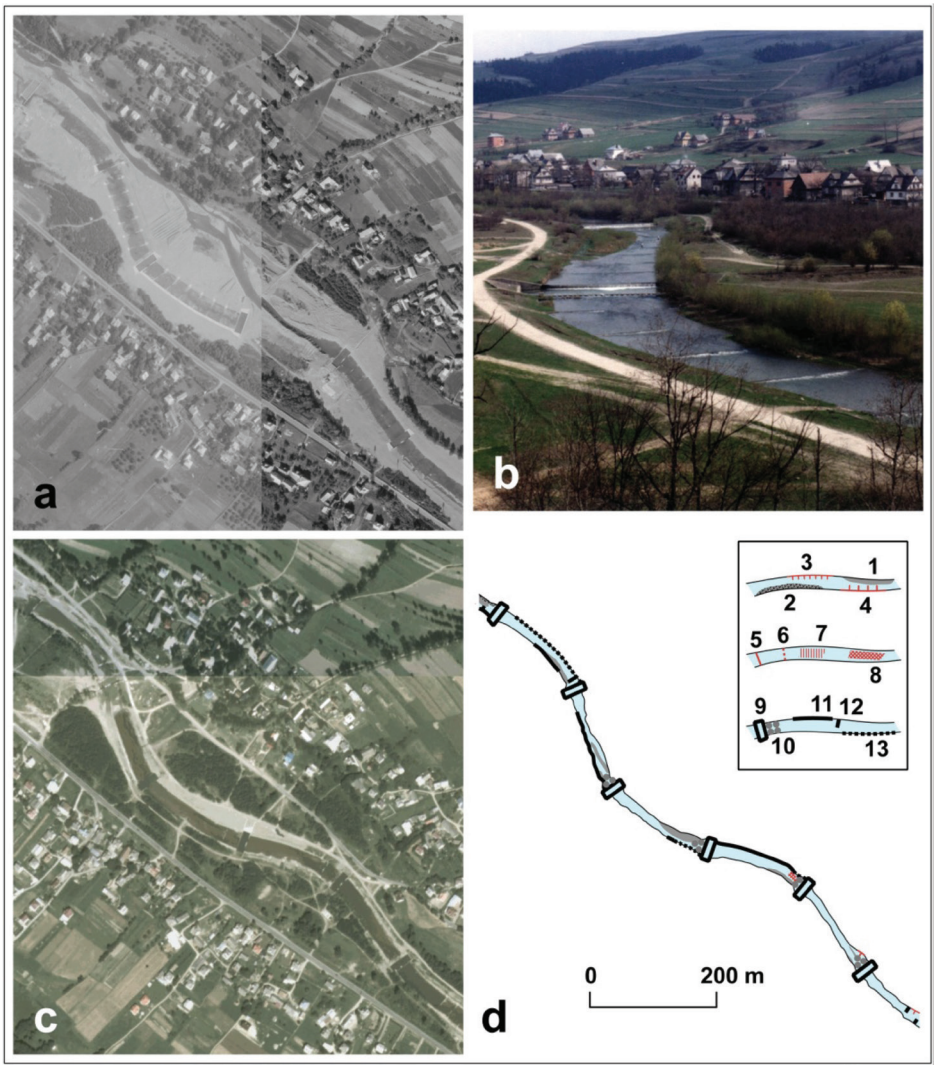
The channel section included in the 1st training stage revealed a relative horizontal and vertical stability. Fragments of the former active channel, which were "cut off" due to the training and narrowing, were transformed into a floodplain and in some place even into a terrace (Fig. 4b).

Figure 4. Change of the Mszanka channel morphology at the section regulated during the first training period : a – 1976, b – 1992 (Photo M. Komędera), c – 1997, d – 2015 (on the basis of the terrain mapping). 1 – bar, 2 – vegetated bar, 3 – cutbanks (height >2m), 4 – cutbanks (height 0-2 m), 5 – rocky step, 6 – boulder step, 7 – riffle, 8 – rocky outcrop, 9 – concrete drop structure, 10 – oversize boulders, 11 – embankment of concrete elements, 12 – concrete step, 13 – rip-rap.

Serious changes in the channel morphology were the result of a high flood in July 1997. However, renovation works were conducted immediately in the channel, as may be seen in the aerial photograph taken only a month after the flood. The section from the debris dam to the Porębianka mouth was almost wholly cleared and the banks, especially concave ones, were renovated, which evidences intensive activity of lateral erosion during the flood (Fig. 4c).

The terrain mapping repeated in 2015 revealed considerable changes in the channel morphology. Along its whole length the river was incised into the bedrock. A thin and discontinuous alluvia layer was present only in some places. Numerous rocky outcrops appeared in the bottom (Fig. 4d, 5d, 6d, 7b). A small, comparable number of bars occurred at each river section, whereas the forms differed considerably with their sizes (Table 1). At the section trained during the first two periods of training, the bars were small and usually lateral (Fig. 4d, 5d). The section regulated in 2003 revealed the presence of large bars, of which the biggest were central forms (Fig. 6d). Big cutbanks appeared at this section (Fig. 7c), as well as rocky steps with an average height of ca. 0.25 m. Few and small erosion forms visible as cutbanks were observed also at the river section closest to the dam. The least of the forms were in the central river reach, which has undergone renovation works in 2013 (City Office Mszana Dolna, 2013). Engineering structures along the whole lower Mszanka section are damaged or even destroyed. It refers particularly to the bank reinforcements, which slide and fall

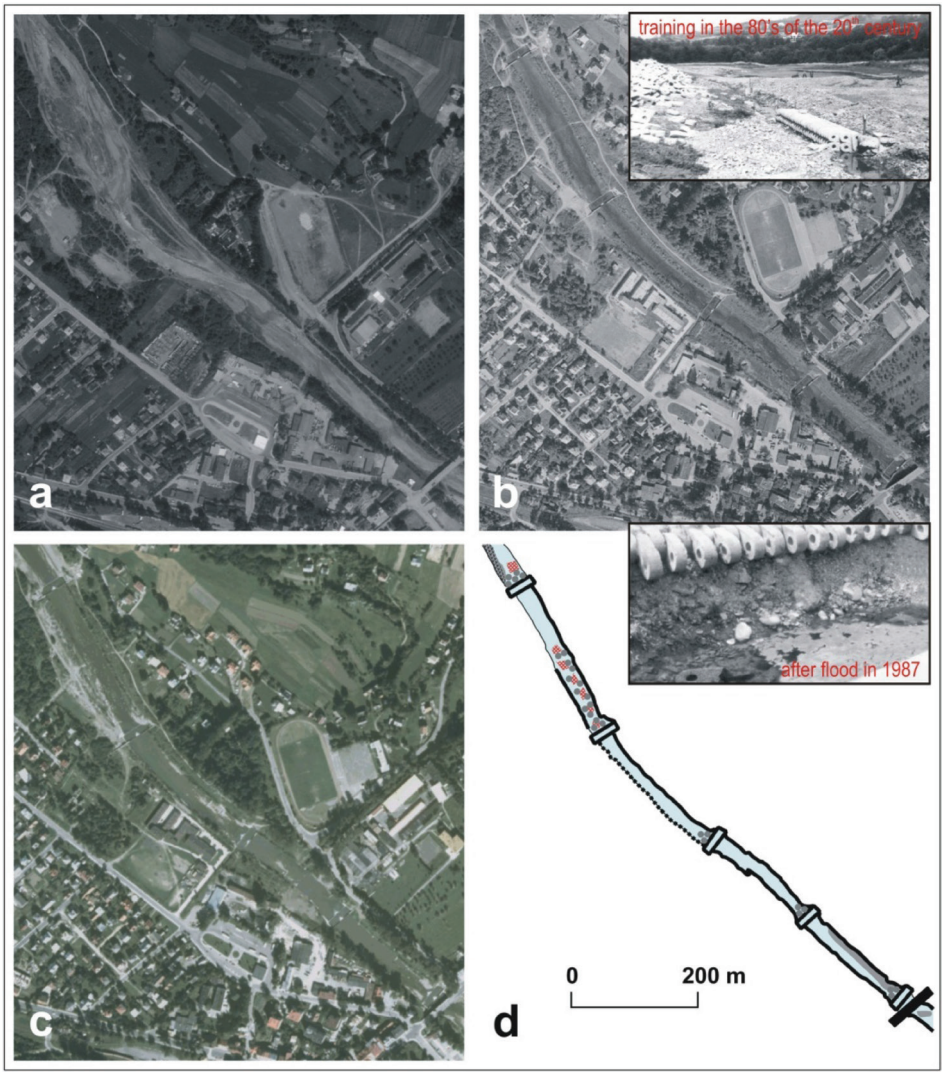
A lack of stability characterised the river section below the Porębianka mouth. Erosion occurring at this section caused the bottom deepening and banks widening. The 2nd stage of training was planned in order to inhibit erosion, limit the bedload transport and to provide flood protection for the adjoining areas, municipal facilities, bridges and roads in the city of Mszana Dolna. The training works were completed in 1989 and the last drop structure was constructed at the 2.140 km of the river. The works comprised levelling of the channel bottom, which totally disturbed the armour layer of bedload and destroyed all channel forms (Photo in Fig. 5b). The artificial flow regulation route was formed (Fig. 5b). The as-built inventory conducted after the works completion revealed considerable differences between the project and real state (project 4175, 1989). The height of the drop structures was not 1 m as planned, but ranged between 0.63 and 1.21 m. The value of channel gradient, instead of expected 5.5‰ along the whole reach, differed between the structures (2.7-4.7‰). The results of considerable reduction of the flowing water volume and negligence of the executor became apparent quite soon. Numerous damages of the new route (acc. to project no. 4175, 1989) were noted already after a small flood wave passing in May 1987 (i.e. even before the works were completed). Potholes up to 1 m deep formed before some drop structure crests. The bottom basins armouring of

gabion rock mattresses was damaged or totally destroyed and in these places 0.3-1.1m potholes formed. Concrete steps were scoured and 0.2-1.3 m deep potholes were forming below them. Some concrete steps and bank reinforcements were damaged or destroyed (Photo in Fig. 5b).

Figure 5. Change of the Mszanka channel morphology at the section regulated during the second period of training: a – 1976, b – 1993 (photographs of the as-built inventory of the flow regulation route acc. to project 4175), c – 1997, d – 2015 (based on terrain mapping). Legend as in Fig. 4.

Numerous bars, visible in the channel bed below the Porębianka mouth were mostly deposited during the flood (Fig. 5c). Many drop structures were partly or wholly covered by the bedload. Concave banks were undercut, which caused their local scouring and destruction of bank reinforcements. Renovation of the analysed channel section (3.928-2.140 km) was carried out in 1998 (acc. to Zestawienie... 2004). Both banks were armoured with concrete prefab bands and the channel was cleared by removing the accumulation forms. Subsequent renovation works were conducted after the flood in 2001.

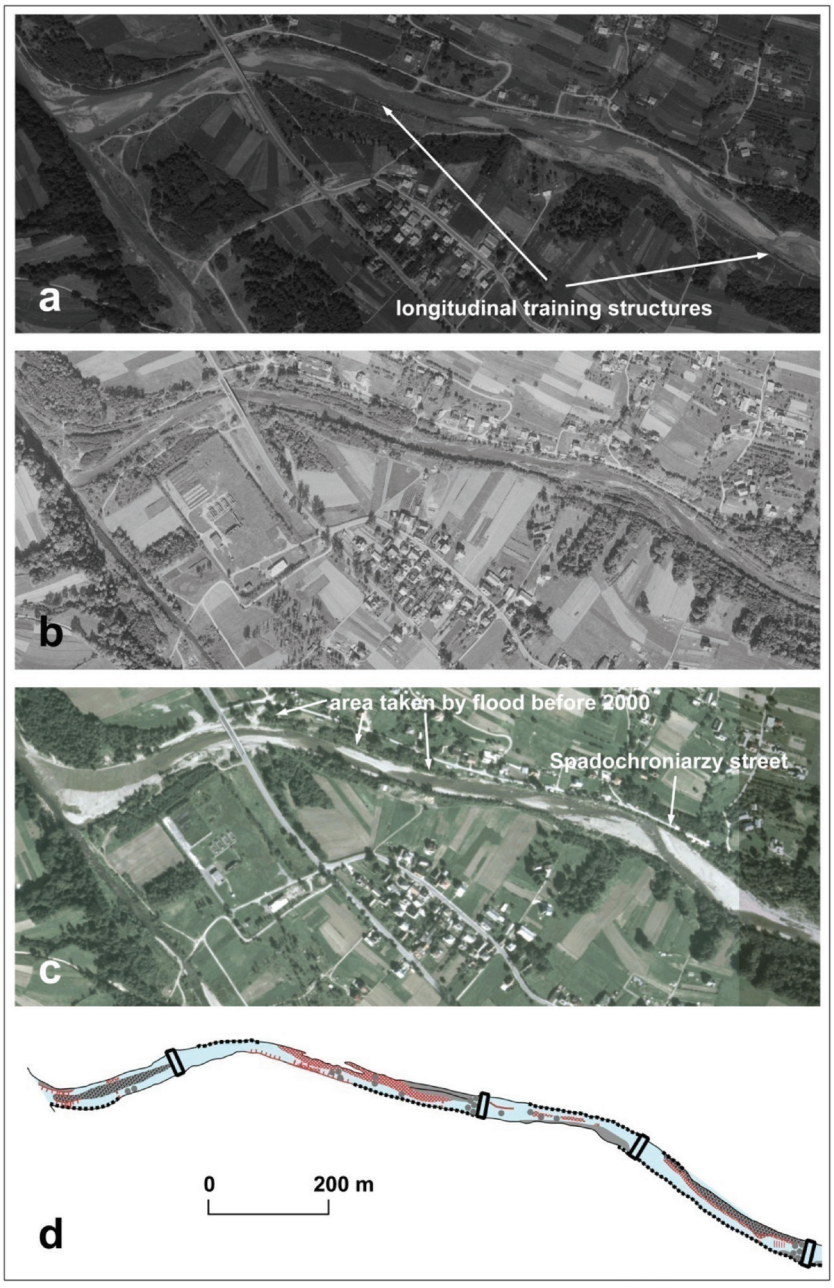
In its final, mouth section, so far not included in training by means of stage correction, in 1993 the channel was single thread and narrow. Its width did not exceed 25 m (Fig. 6b). It was the result of training conducted in the 1970s using groynes and longitudinal dikes.

Figure 6. Change in the Mszanka channel morphology at the section regulated during the third period of training: a – 1976, b – 1993, c – 1997, d – 2015 (based on the terrain mapping). Legend as in Fig. 4.

The final, mouth section of the Mszanka River was considerably widened in August 1997 in comparison with its state in 1993 (Fig. 6c). The floodwater, overflowing the artificially narrowed channel, destroyed bank reinforcements.
