INFRASTRUKTURA I EKOLOGIA TERENÓW WIEJSKICH
INFRASTRUCTURE AND ECOLOGY OF RURAL AREAS

Piotr Herbut

AIR MOVEMENT CHARACTERISTICS INSIDE A COW BARN WITH NATURAL VENTILATION UNDER NO-WIND CONDITIONS IN THE WINTER SEASON

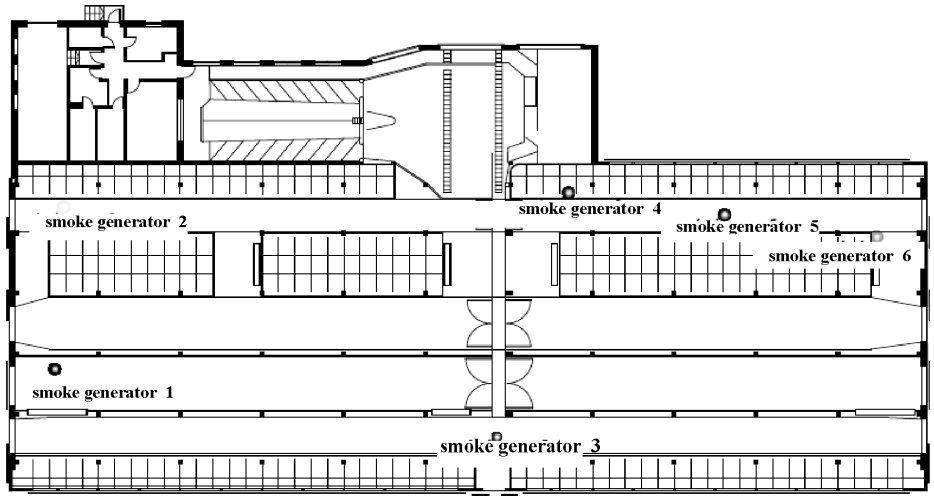
Figure 2. The distribution of smoke generators in six characteristic points of the building during the experiment – an overview

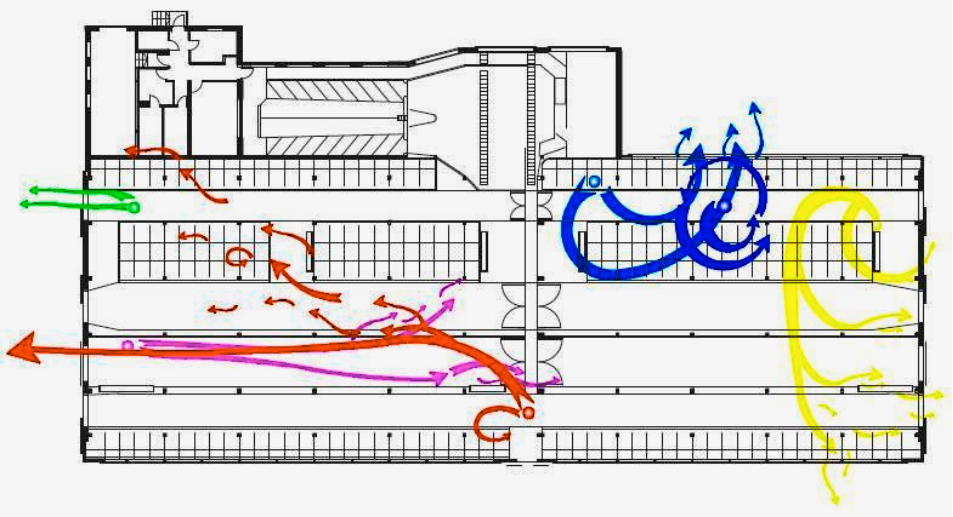
Under no-wind conditions and with curtain walls and entrance doors wide open (wind velocity lower than 0.5 $m \cdot s^{-1}$), the air moved along longitudinal corridors of the barn (marked in red and purple). In the vicinity of stalls and the manure corridor, certain smoke turbulences appeared (marked in blue and navy blue) (figure 3 and 4). At the north-western wall, some of the smoke (marked in yellow) moved across the cow barn between the open curtain walls and got out of the building through openings in the gable wall (figure 3 and 4). The observed air movement occurred most of all above the occupied zone (just below the ceiling), which points to the lack of suitable barn ventilation system.

Figure 3. The movement of smoke from smoke generators in six characteristic points of the main hall with curtain walls wide open – an overview

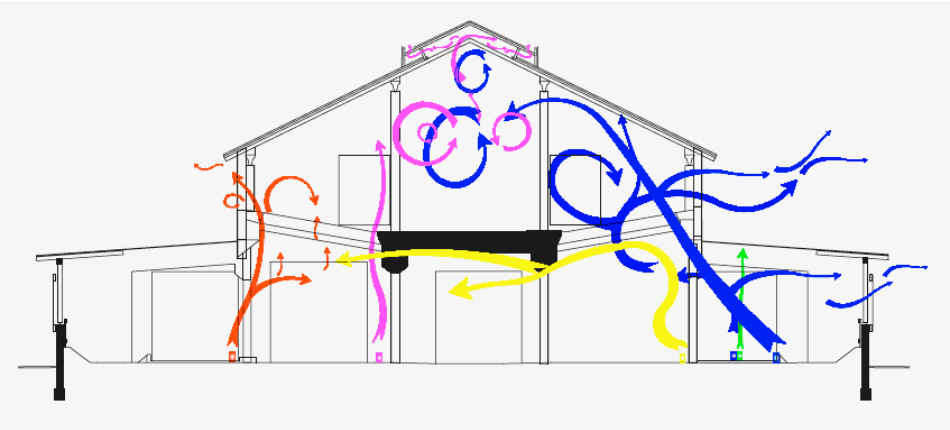
The vertical air movement was momentarily very rapid. In most cases, smoke produced by a smoke generator moved quickly upwards towards the roof ridge and outlet openings above the ceiling. In this zone, certain smoke turbulences could be observed and afterwards the smoke escaped outside the barn (figure 4 and 5).

Figure 4. The movement of smoke from smoke generators in six characteristic points of the main hall with curtain walls wide open – a cross-section

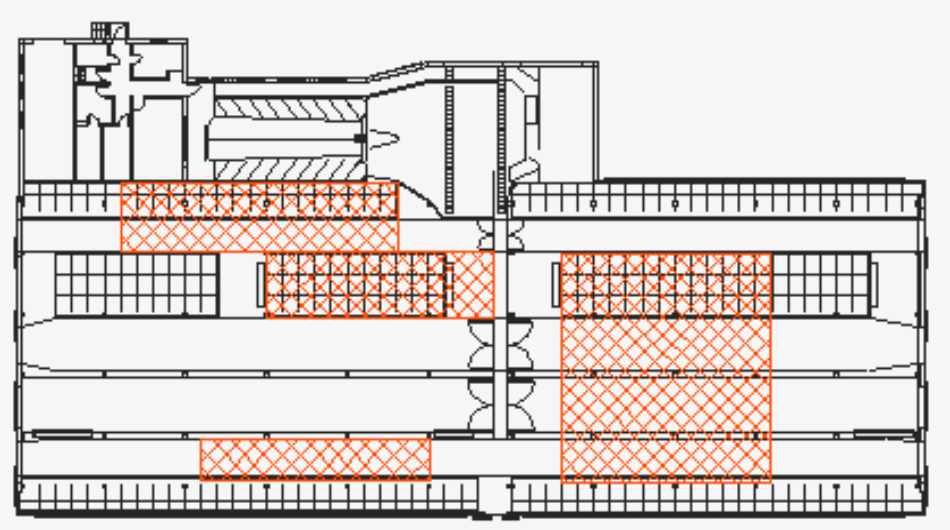
However, at times the air swelled inside the building instead of escaping outside and created standstill zones.

Based on the analysis of observation results, it was possible to determine the localization of such zones (fig. 6) with a recommendation to install fans (air mixers) in these particular spots equipped with an inclination adjustment facility. Their role would be to transfer the used air horizontally or vertically towards the open doors and curtains at no-wind conditions.

Figure 6. An overview of the cow barn with zones where used air stood still (marked in red)

5. Since it was possible to determine zones where air stood still, the recommendation is to introduce an additional active cooling system in the summer with the help of fans installed over animal stalls.
