INFRASTRUKTURA I EKOLOGIA TERENÓW WIEJSKICH
INFRASTRUCTURE AND ECOLOGY OF RURAL AREAS

Nr IV/3/2016, POLSKA AKADEMIA NAUK, Oddział w Krakowie, s. 1547–1557
Komisja Technicznej Infrastruktury Wsi

RELIABILITY OF SEWAGE TREATMENT PLANTS PROCESSING SEWAGE FROM SCHOOL BUILDINGS LOCATED IN NON-URBAN AREAS

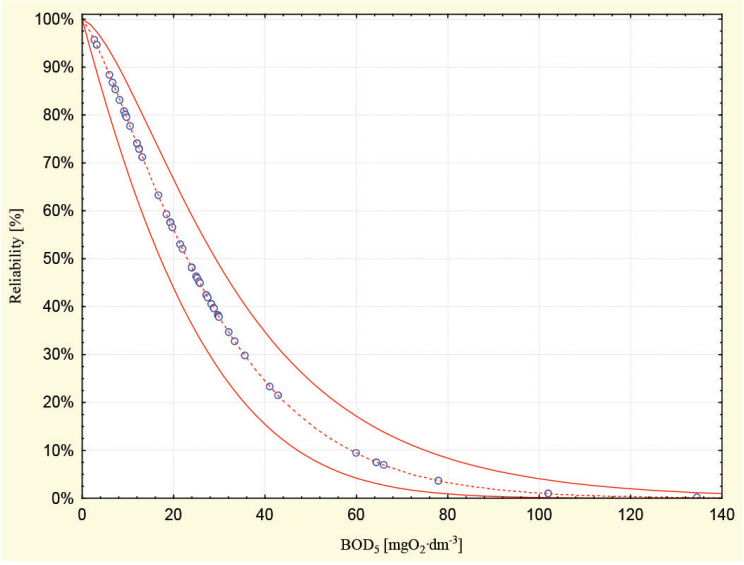
Reliability analysis for BCT S-12 revealed that BOD_5 limit in the treated sewage was not adhered to at BCT S-12 in about 23 % of cases. Therefore, the

Figure 1. Results of Weibull reliability analysis for BOD_5 concentrations in the treated sewage for BCT S-12 facility

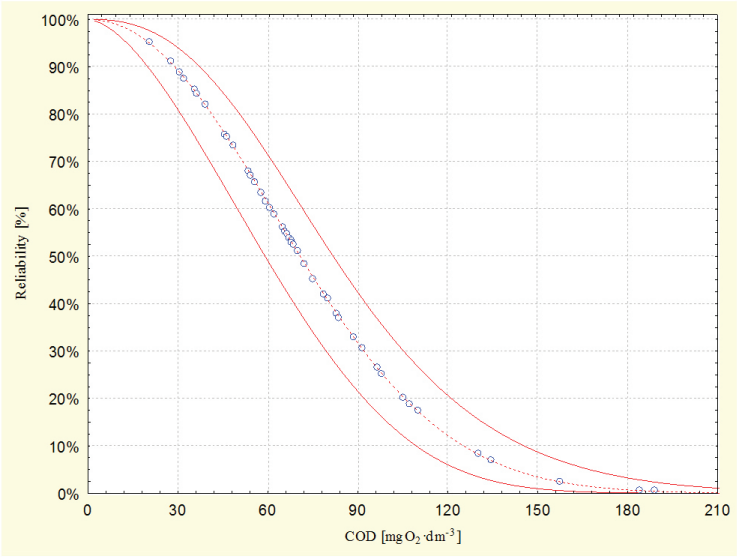
concentration of BOD_5 may be higher than permitted for nearly 84 days per year. For COD, the limit was exceeded in 4 % of cases. This means that the values may be above the limit for 14 days per year. Reliability analysis for total nitrogen removal showed that its permissible concentration was exceeded in 48 % of cases. This translates into as many as 175 days per year when the determined concentration may be higher than the limit. The outcomes of Weibull reliability method for BOD_5, COD and total nitrogen in the treated sewage from BCT S-12 are presented in Figures 1, 2, and 3.

Figure 2. Results of Weibull reliability analysis for COD concentrations in the treated sewage for BCT S-12 facility

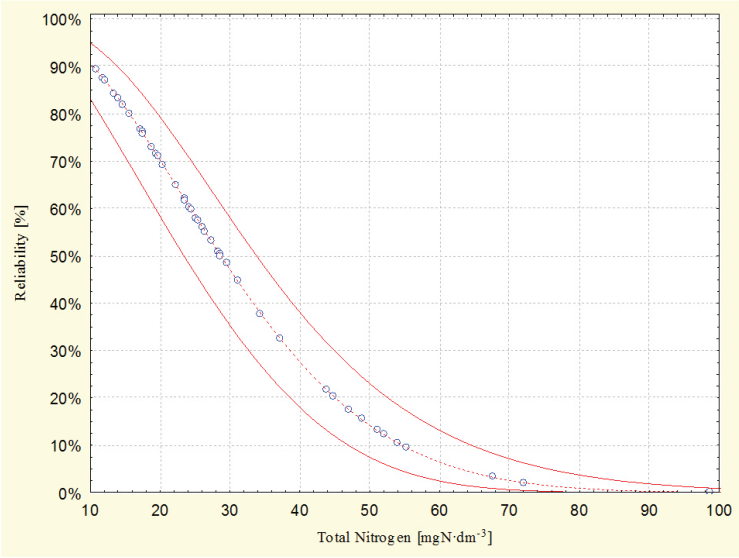
Figure 3. Results of Weibull reliability analysis for total nitrogen concentrations in the treated sewage for BCT S-12 facility

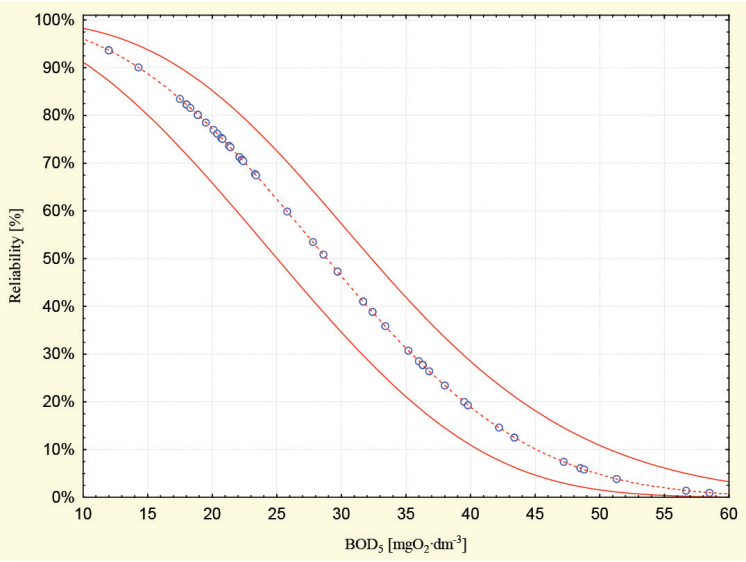
The reliability assessment for TJ EP-4 indicated that the permissible value of BOD_5 in the treated sewage was exceeded in 19 % of cases that is for 69 days per year. COD values were above the limit in 12 % of cases, i.e. for 44 days per year. For total nitrogen, the concentration limit may be broken in 28 % of cases that comes up to 102 days per year. The outcomes of Weibull reliability method for BOD_5, COD and total nitrogen in the treated sewage from TJ EP-4 are presented in Figures 4, 5, and 6.

Figure 4. Results of Weibull reliability analysis for BOD_5 concentrations in the treated sewage for TJ EP-4 facility

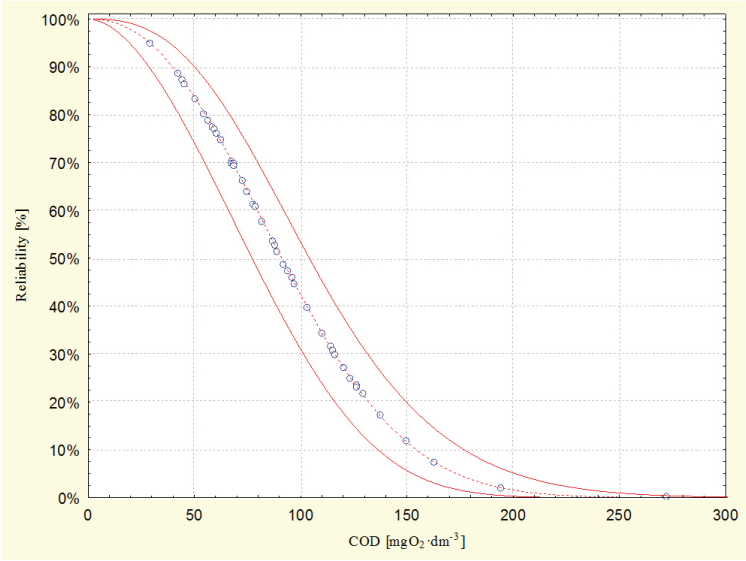
Figure 5. Results of Weibull reliability analysis for COD concentrations in the treated sewage for TJ EP-4 facility

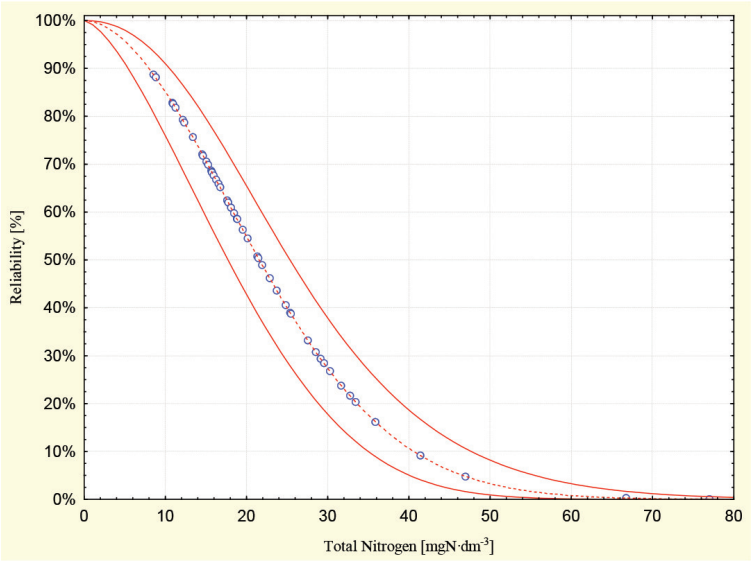
Figure 6. Results of Weibull reliability analysis for total nitrogen concentrations in the treated sewage for TJ EP-4 facility
