## CHARACTERISTICS OF ILLEGAL DUMPING SITES ON THE EXAMPLE OF THE TRZEBINIA MUNICIPALITY

### ABSTRACT

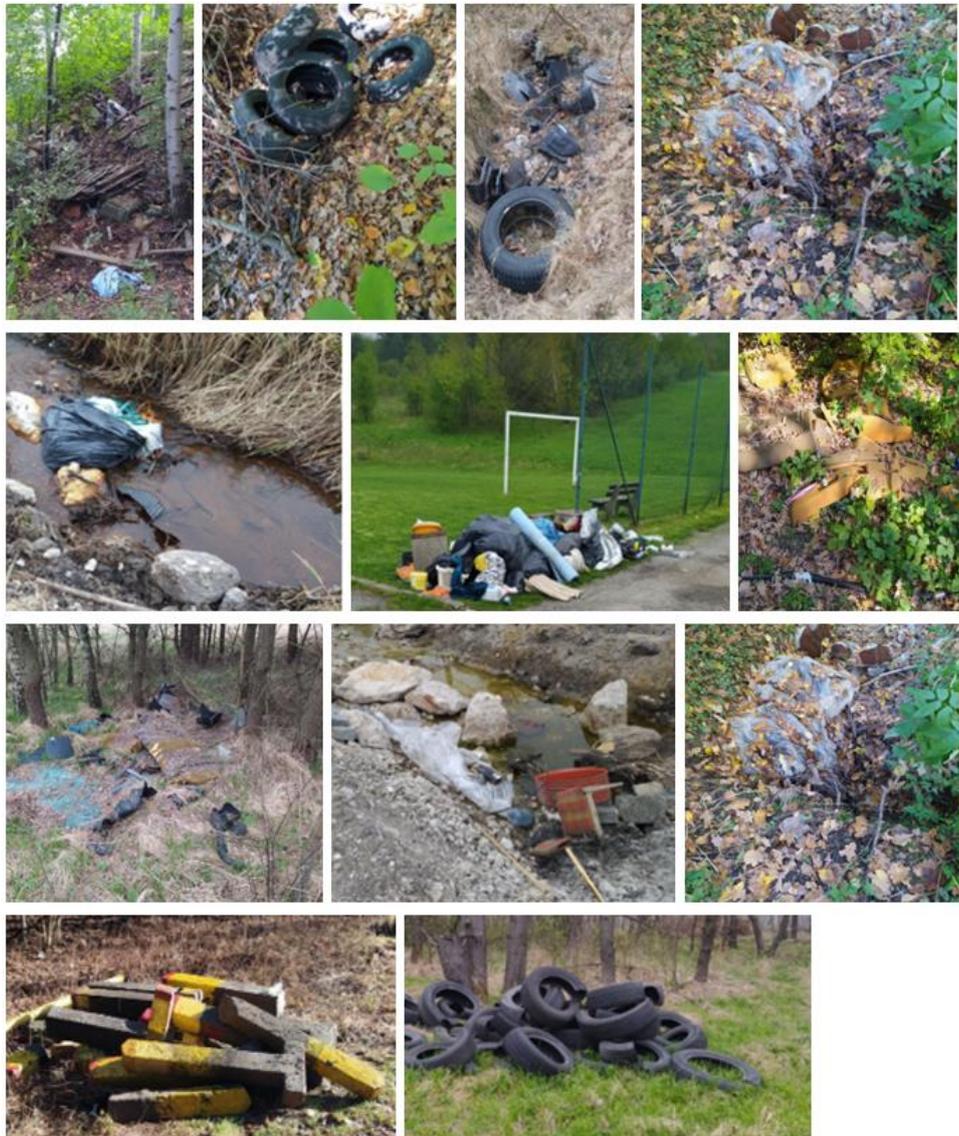
**Figure 10.** Inventoried illegal dumps in the Trzebinia commune.

Figure 10 shows photos of selected illegal garbage dumps in the Trzebinia commune. The results of the analyzes partially confirm the observations of Zabłocki *et al.* (2011) and Malinowski *et al.* (2015), who found that small illegal landfills mainly deposit PET bottles (polyethylene terephthalate), glass bottles and metal cans, while larger landfills contain rubble (construction and renovation waste).
